Case Study: Corrosion of Sheet Piling at Northport – Marsden Point, New Zealand

Corrosion seen at Northport Ltd

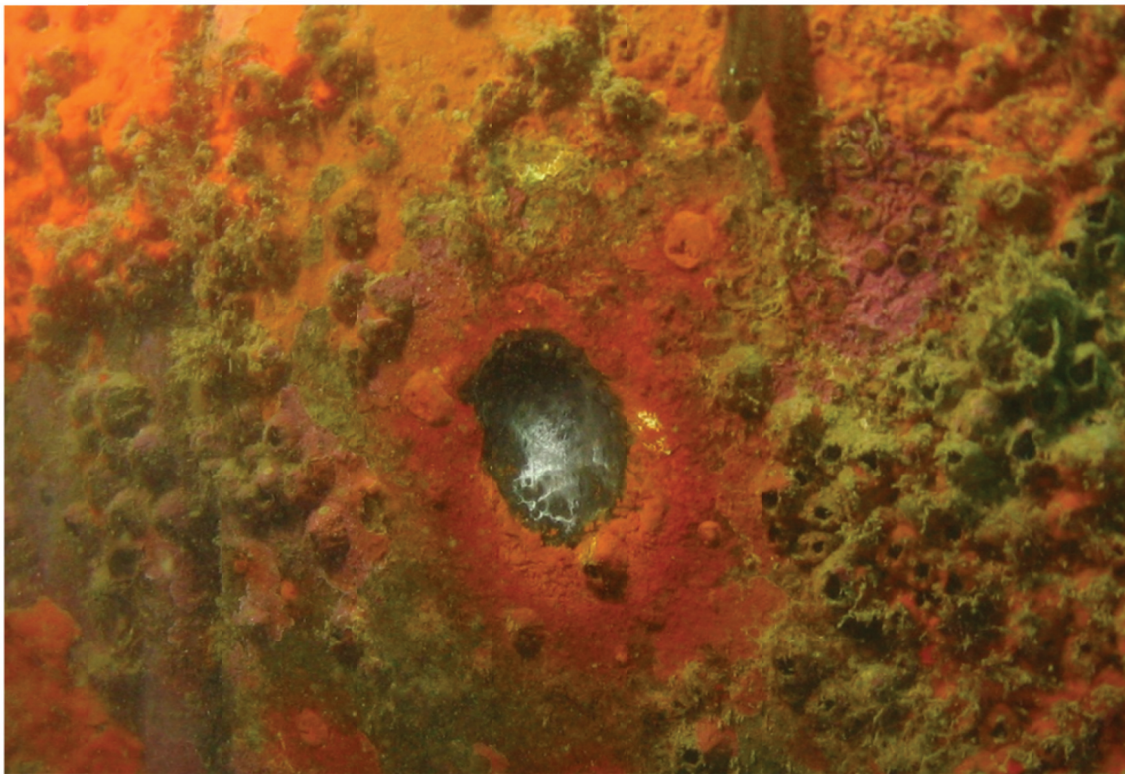
below the intertidal zone (i.e. from +1.0mCD to -2.0mCD). In addition to that, in case the piling was breached, a layer of concrete was poured in behind the piling to act as a solid barrier between the fill material behind the wall and the potentially breached sheet piling layer. During recent

inspection dives, evidence of ALWC seems to be taking place. The rate at which this piling seems to be pitting looks to be high, as can be seen in Figure 3.

Figure 3 - ALWC pitting of sheet piling, 4 - 5mm deep

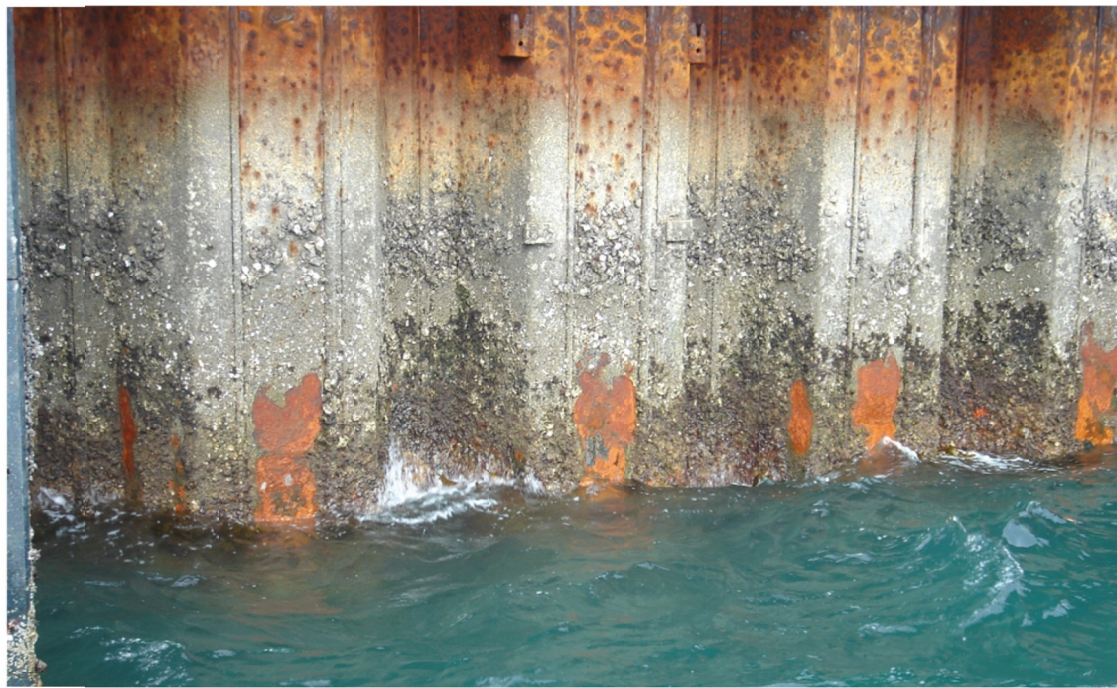
Figure 4 shows the typical orange patches at low water. Below this orange film is bright steel, with the film easily removed by hand.

Figure 4 - Typical corrosion seen on Stage 2 piling at low water

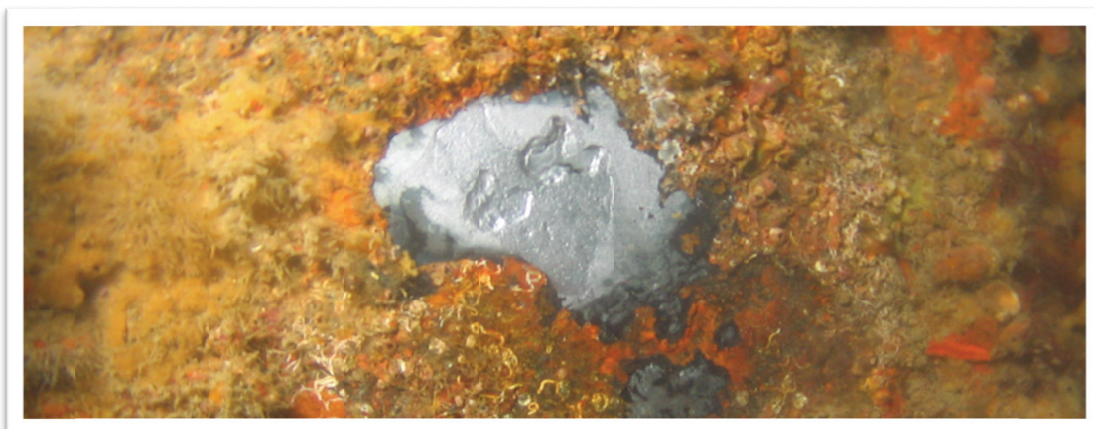
During diving inspections of the piling, the divers have noted that there is a reasonably consistent amount of corrosion on the lower portion of the wall (-11mCD to -13mCD) on Berth 3. Due to its depth it has been suggested that it would not be ALWC, however this does not appear to be general corrosion. The divers have reported that

there are large patches of corrosion that have an orange appearance at first, but with a light rub bright steel can be easily seen. During the rubbing of this surface, black silt is also noted, which appears to be a layer between the external orange appearance and the shiny steel surface. The steel surface is also noted to have localised and

sometimes deep pits, up to 5 – 6mm deep. Further sampling and testing may confirm the presence of MIC.

Figures 5 & 6 show corrosion and pitting noted during diving at the toe of Stage 2. Bright steel is easily exposed by divers rubbing their hand over the surface.

Figure 5 - Pitting occurring at depth, possibly MIC?

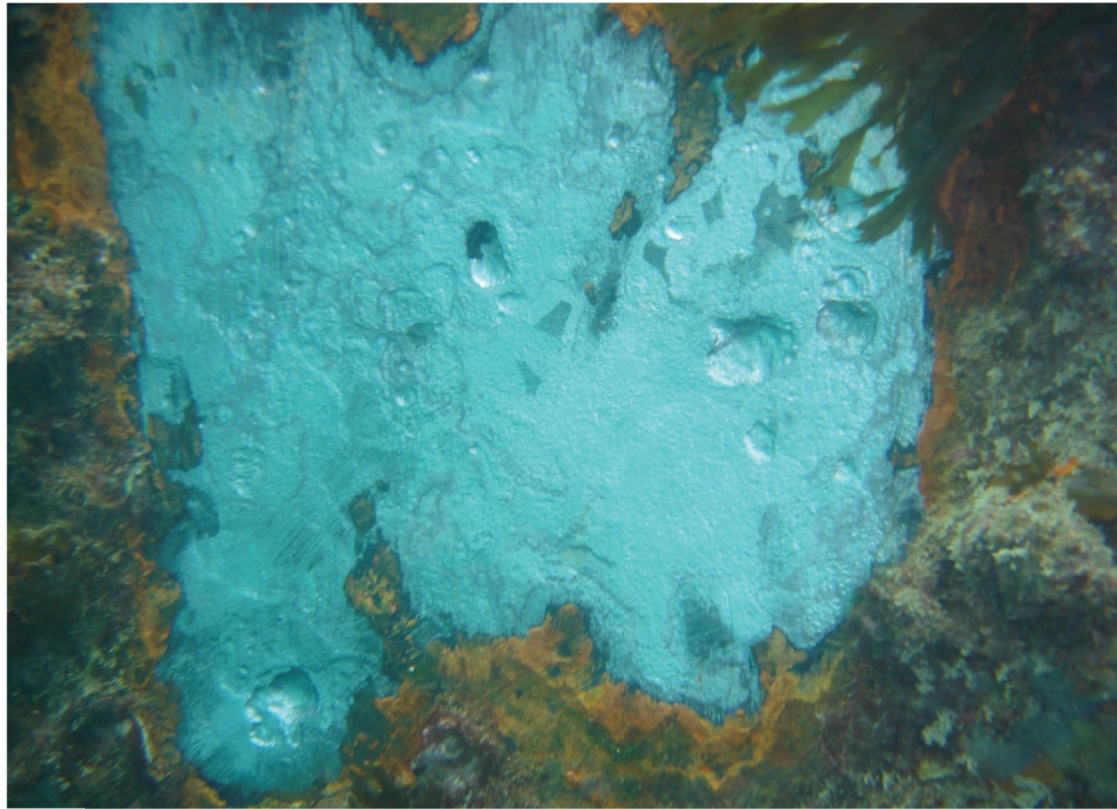
Figure 6 - Corrosion over a large area, with multiple large pits
